# Manhole Inspection Summary

Manhole # S37QQ\_038MH

Insp Date: 1/30/07 1:55 PM

**Location** Address: **2435 GREENMOUNT AVE**

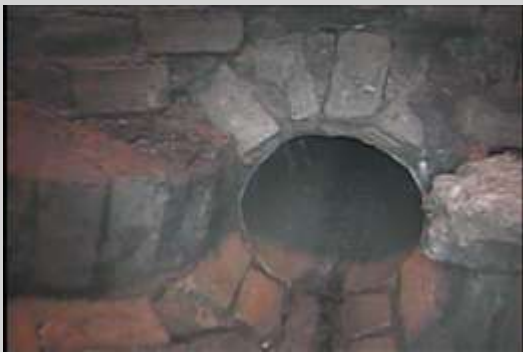
### 8 in. Circular Gravity Sewer Pipe Out @ 12 O'Clock

Pipe Material: **Clay** ☐ Pipe Lined

Invert Depth: **11.45** (ft.) Flow Characteristics: **Slow**

Deposits: ☒ None ☐ Mud ☐ Sludge ☐ Debris ☐ Grease

Infiltration: **None** Pipe Seal Cond: **Unknown**

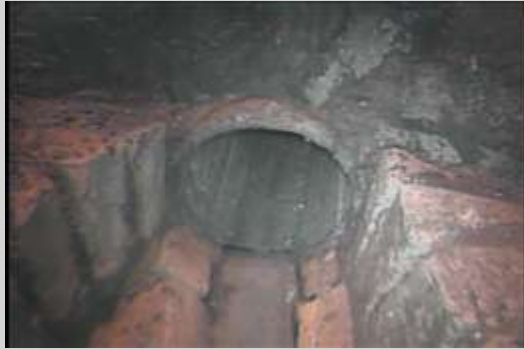
8 in. Circular Gravity Sewer

Pipe Material: **Clay**

Infiltration: **None**
